LLYN Y FAN FACH RESERVOIR (2024)

Grade II listed structure that underwent refurbishment to address safety concerns in the draw-off tower and spillway

By: Alasdair Handley CEng MEng, Amy Jones MEng & Simon Fisher

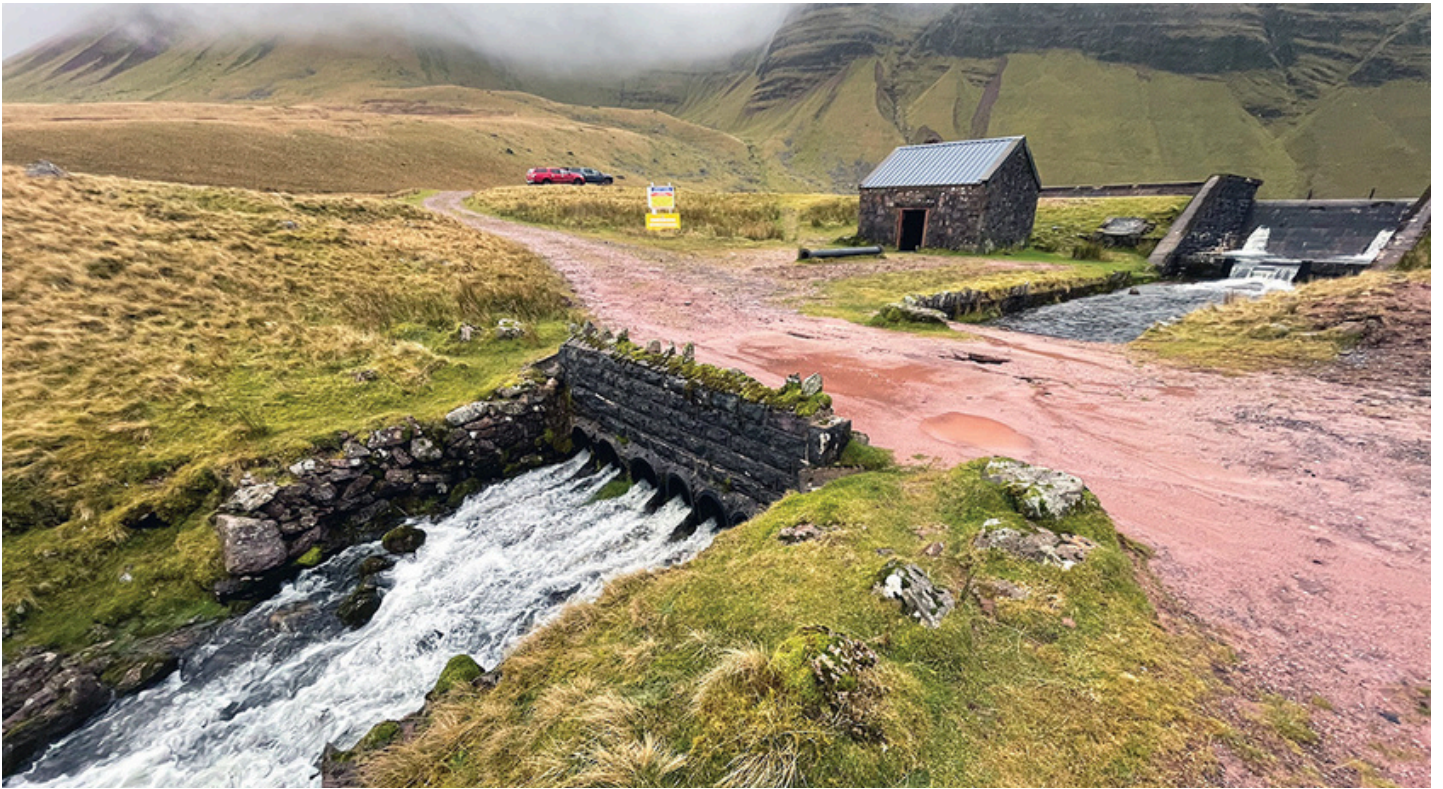
Spillway prior to works – Courtesy of Arup

The proposal was to fully replace the lower spillway with a precast structure capable of passing the 1,000 year (design) and 10,000 year (safety) flood events for the Category B dam. The wall heights were designed to contain the flows including full USBR freeboard. In order to maintain cultural heritage of the existing spillway, the spillway was lined with stonework.

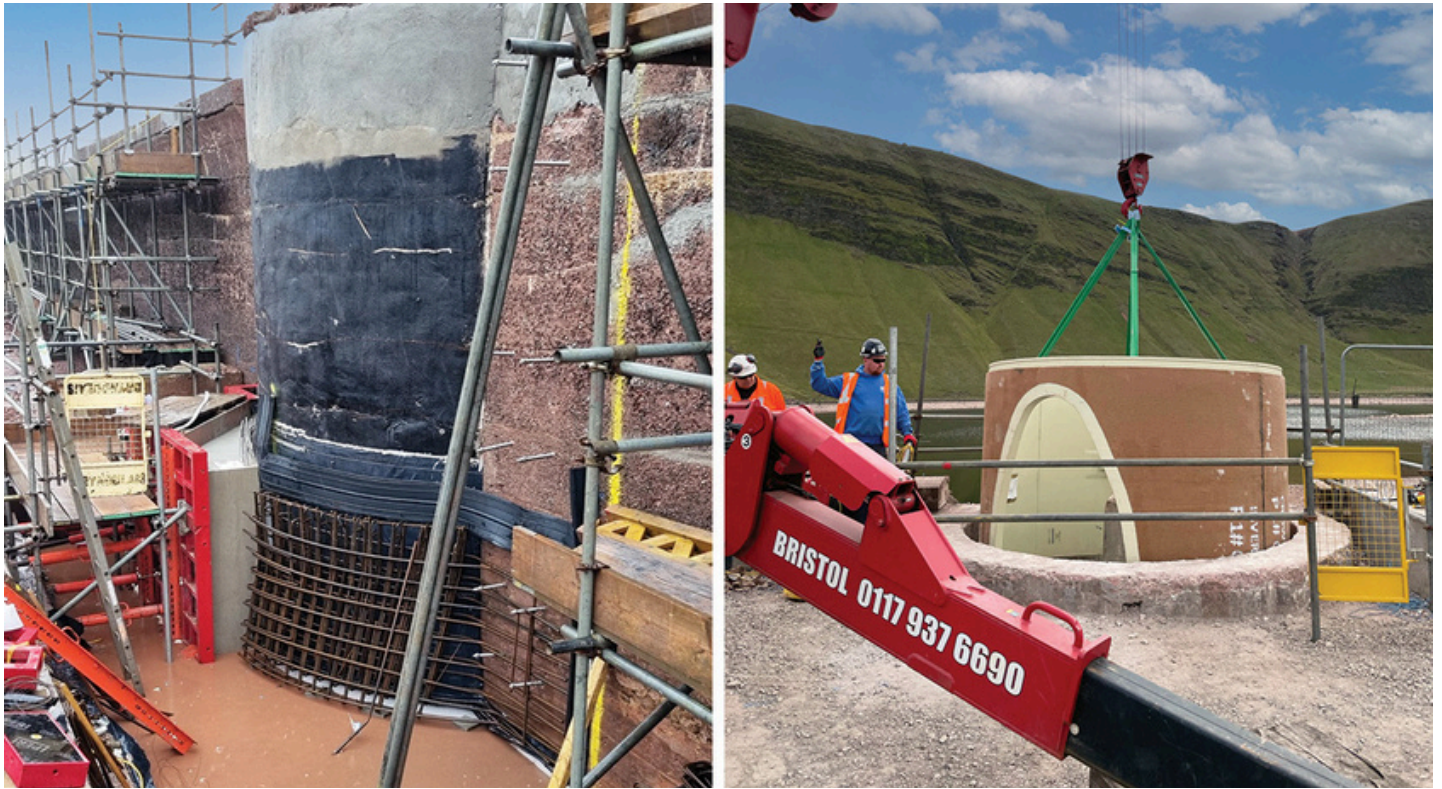
(left) External lining construction – Courtesy of Arup, and (right) Installation of GRP lining from iLine Technologies Ltd – Courtesy of Morgan Sindall

1. A glass reinforced plastic (GRP) liner that is flexible enough to accept the thermal strains of the existing dam wall elastically, whilst being strong enough to resist the hydrostatic loading from the reservoir. The GRP liner is also designed to withstand the environmental conditions within the tower as it is the primary means of preventing water ingress to the shaft. [Arup](#) worked closely with the supplier, iLine Technologies Ltd, to guide their design and verify it met the requirements.

3. A new reinforced concrete wall on the upstream face of the tower to structurally replace the cracked valve tower wall. This wall is made of two leaves cantilevering from the dam walls with a movement joint down the middle. This structure will also insulate the cracks and their repairs from environmental effects as well as being the first line of water ingress defence with a waterbar around its perimeter and waterproofing admix.

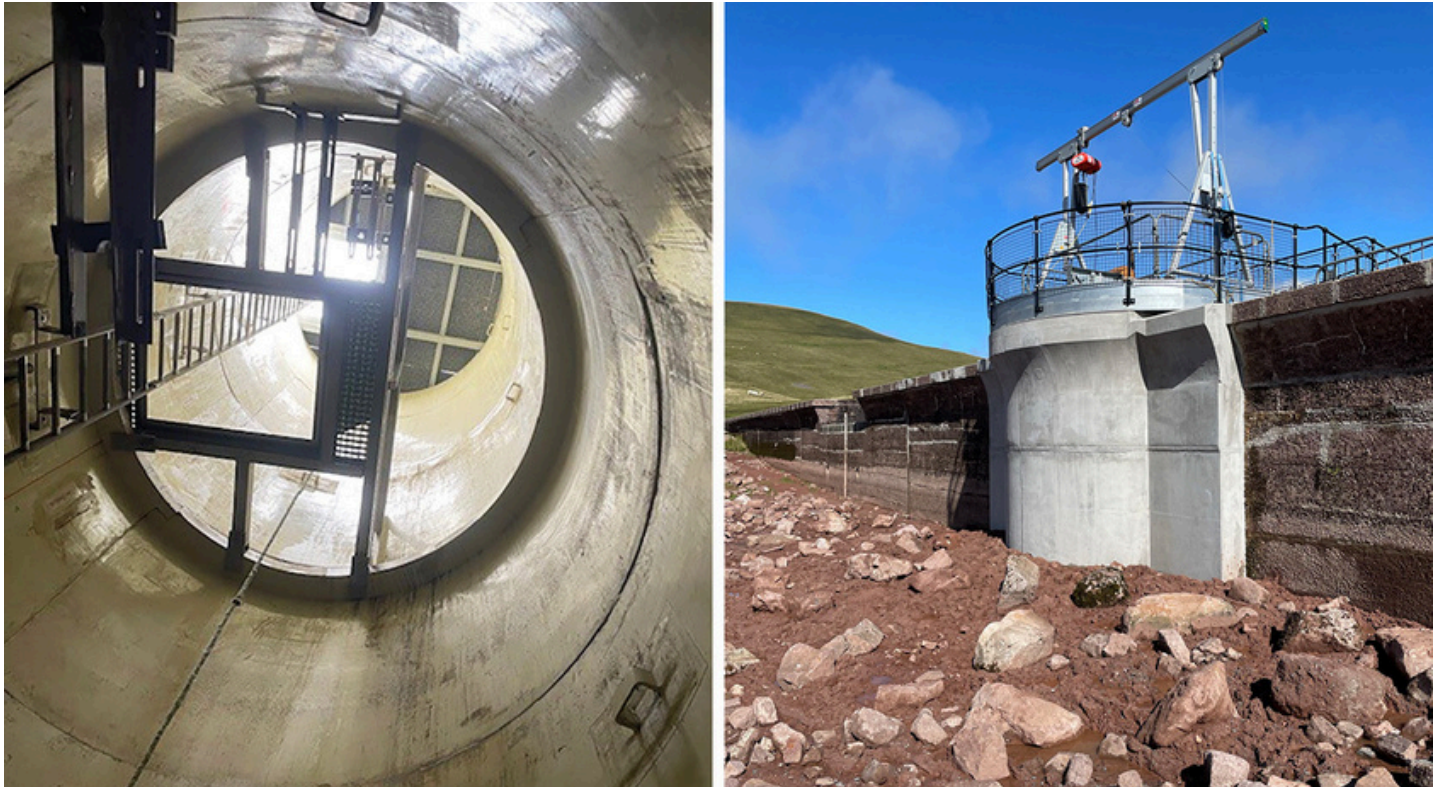
(left) Lined tower – Courtesy of HR Wallingford, and (right) Completed external lining – Courtesy of Morgan Sindall

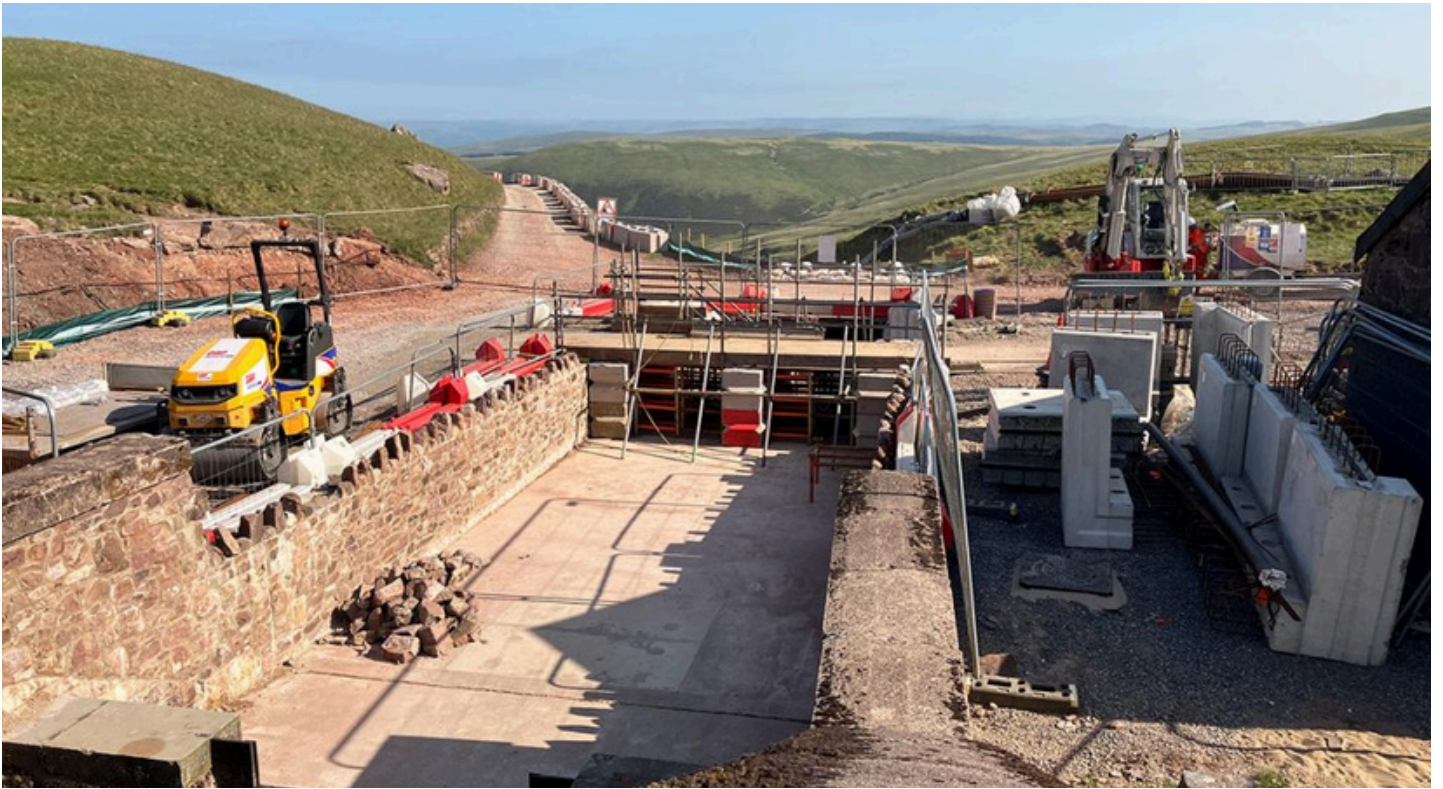
Spillway construction and lining – Courtesy of Morgan Sindall

A significant constraint was the low clearance and low capacity bridges on approach to the site. This restricted the size of plant that could be transported and in turn, the size of components that could be handled. Therefore a large number of precast concrete units were required to make up the spillway structure with a considered and minimised use of in situ stitches. Another example where this constraint influenced delivery was that the tower required GRP sections with a 2.7m internal diameter being transported over a 2.4m wide bridge. The rings were therefore formed in half sections and assembled in situ.
